ASSOCIATION OF TOURIST & HERITAGE RAIL AUSTRALIA

ATHRA ALERT #31 – April 2007

Wagon Headstock Carrier Plate

Warning of Potential Asbestos Material

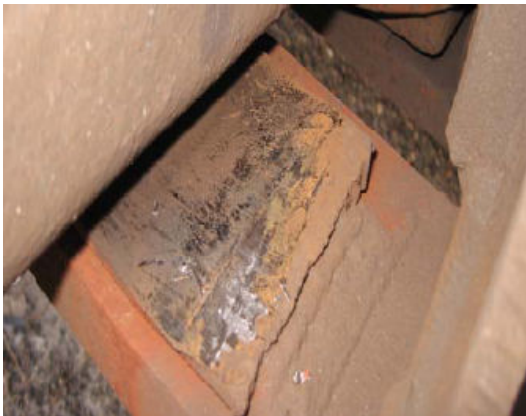
Carrier Plate Steel Wear Liner

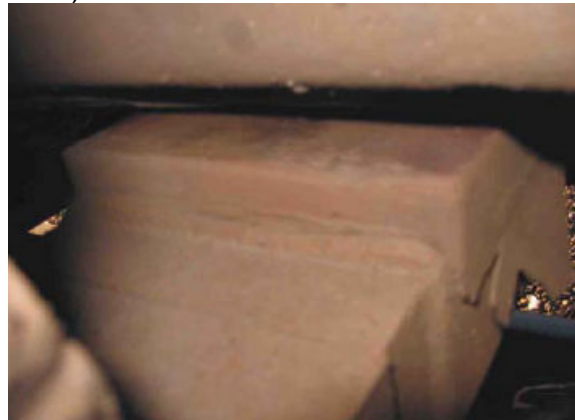
Carrier Plate Rubber Wear Liner

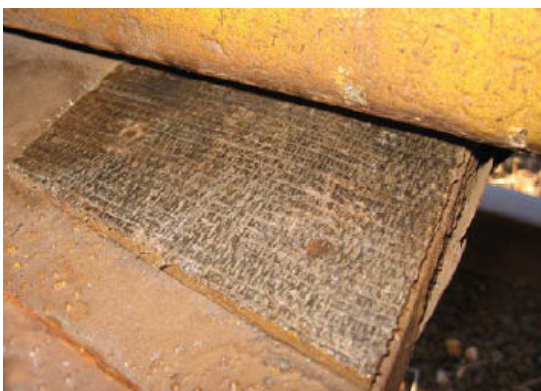
Carrier Plate Fibrous Material Containing Asbestos Wear Liner

- Wear liners that are either damaged or broken need to be removed from service so that the wear liner can be replaced with a non-fibrous material.
- Wear liners that are in good condition will remain in service, however they will be sealed with an adhesive product to prevent any potential wear products from being released.
- When a train arrives into a terminal it will be inspected and where a wagon is identified with an asbestos wear liner, a suitably trained person will inspect the liner and seal it with an adhesive product.
- The services of licensed asbestos removalists will be used to remove wear liners and any remaining wear liner debris prior to a non fibrous wear liner being fitted.

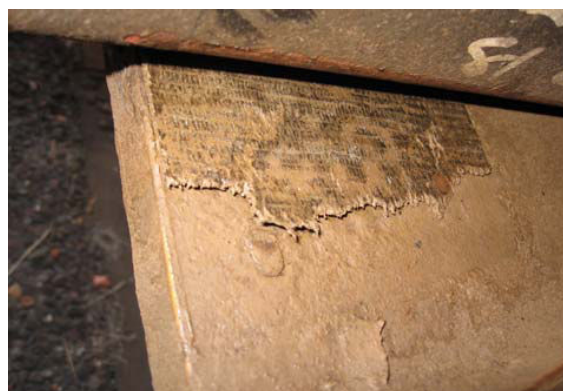
Fibrous Wear Liner in Poor Condition To be Removed from Service
