## ASSOCIATION OF TOURIST & HERITAGE RAIL AUSTRALIA

### ATHRA ALERT #33 – April 2007

## Older Diesel Locomotives Warning of Possible Presence of Bonded Asbestos Materials

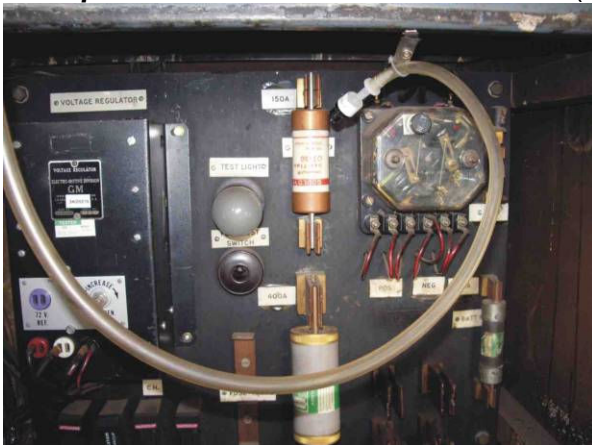
Cabin fuse & battery knife switch backing board in a Y class locomotive

Pacific National is developing a program to remove all bonded asbestos material that is identified in the arc chutes across its locomotive fleet. Pacific National has also determined that the material present in the electrical backing boards in electrical compartments is of a bonded asbestos type and unless obviously damaged or mechanically disturbed, does not require systematic replacement.

- Make this Alert available to your locomotive maintenance crews and drivers.
- Ensure your procedures for identifying, working with and removing asbestos and asbestos containing materials comply with the requirements of your State regulations.
- Ensure your locomotive maintenance crews understand the appropriate procedures for working with asbestos containing materials and the health risks of not following the required procedures.
- Establish a procedure to identify and record the types of backing boards and contactor arc chutes in your locomotives and to record the removal of asbestos containing materials if found.
- Undertake a risk assessment of all identified bonded asbestos materials to determine if it can be safely maintained in-situ or if a program of replacement is required.

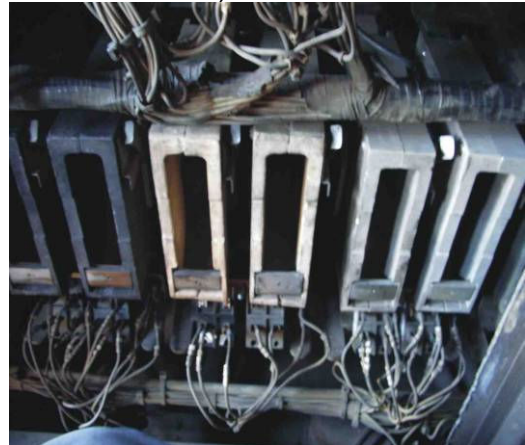
Engine room arc chute in an X class  
The black coloured arc chutes to the left were found to contain bonded asbestos.
