ASSOCIATION OF TOURIST & HERITAGE RAIL AUSTRALIA

ATHRA ALERT #32 – April 2007

Asbestos Detected in Bogie Side Bearer Fibrous Wear Liners

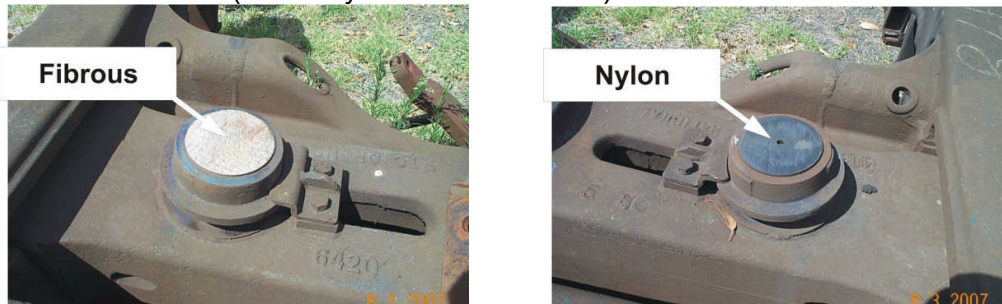
Wear Liner Identification (Courtesy of Pacific National)

The fibrous type wear liners have a distinctive woven appearance (cross check) and are generally light grey in colour. Nylon type wear plates generally appear as dark grey in colour or in some cases yellow. These materials will not show evidence of fibres.

- Make this Alert available to your rollingstock maintenance crews.
- Ensure your procedures for identifying, working with and removing asbestos and asbestos containing materials comply with the requirements of your State regulations.
- Ensure your rollingstock maintenance crews understand the appropriate procedures for working with asbestos containing materials and the health risks of not following the required procedures.
- Establish a procedure to identify and record the types of wear liner materials present on your rollingstock and to record the removal of asbestos containing materials if found.
